**HOUSE DOCTOR**

# Inspection Report

**03501, Alicante, Your Dream House Location, Alicante, Spain**

**26.06.2026**

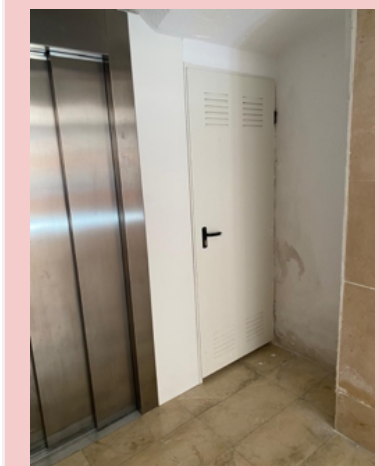
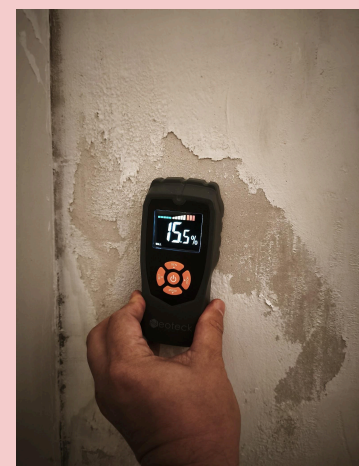
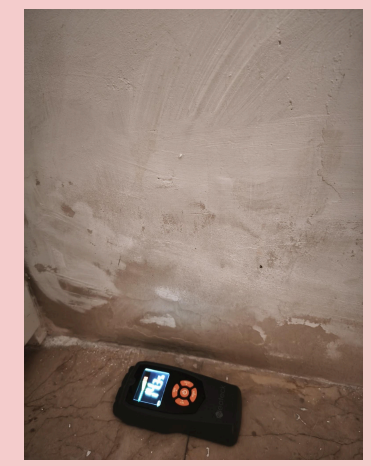
### Entrance hall. Defects

| Category | Condition | Description | Defects |
|---|---|---|---|
| Entrance hall | <br>average | <ul style="list-style-type: none"><li>The main section of the entrance hall is in good condition, with evidence of recent refurbishment</li></ul> | <ul style="list-style-type: none"><li>A section of the wall was found to exhibit significant plaster and paint delamination, accompanied by elevated moisture levels</li></ul> |

The inspected area exhibits the following conditions:

- Localised deterioration and delamination of the plaster finish;
- Evidence of previous repair works;
- Elevated relative moisture readings in the wall and floor (approximately 15–16%), which may indicate the presence of residual or ongoing moisture within the building fabric;

As this inspection was limited to a visual, non-destructive assessment, it was not possible to determine the source of the moisture, the time at which the defect developed, or whether the previous repair works fully addressed the underlying cause.

- Request information from the seller or property management regarding the recent entrance hall refurbishment. Clarify if the source of moisture ingress has been identified and addressed;
- If necessary, investigate the affected area further after removing the surface finish to determine the root cause of the damage.

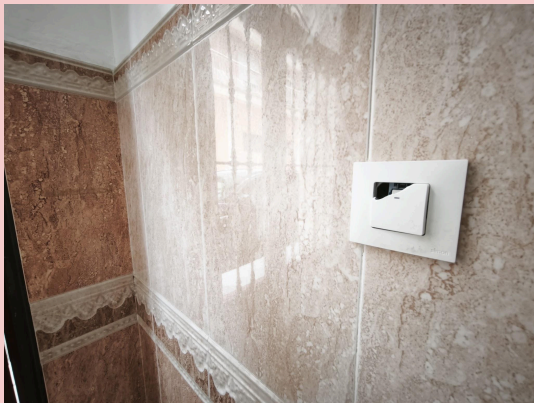
### Lighting. Defects

| Category | Condition | Description | Defects |
|---|---|---|---|
| Lighting | <br>average | <ul style="list-style-type: none"><li>Lighting with automatic time-off control, found to be operational at the time of the inspection</li></ul> | <ul style="list-style-type: none"><li>Damaged light switch on the ground floor, presenting a potential risk of electric shock</li></ul> |

- The light switch in the common entrance area is damaged, presenting a potential risk of electric shock

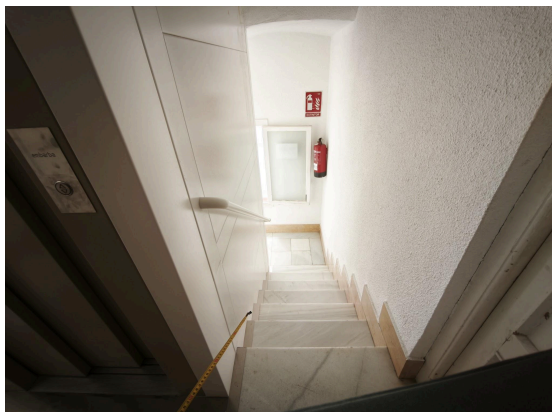
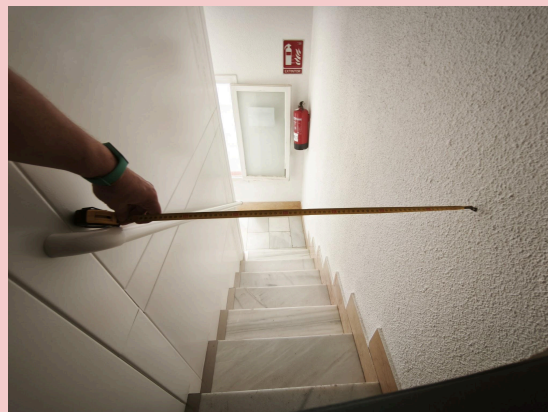
## Staircases. Overview and Defects

| Category | Condition | Description | Defects |
|---|---|---|---|
| Staircases | <br>average | <ul style="list-style-type: none"><li>No cracks, deformation, or other signs of structural distress were identified in the stair flights</li></ul> | <ul style="list-style-type: none"><li>The stair flights are exceptionally narrow (approximately 0.7 m), which is below the width typically required by current building standards (CTE)</li></ul> |

- The stair flights have an approximate width of 0.70 m, which is below the minimum width specified by the current Spanish Building Code (CTE: 1.00 m). This may result in difficulties when transporting furniture and other large items between floors.

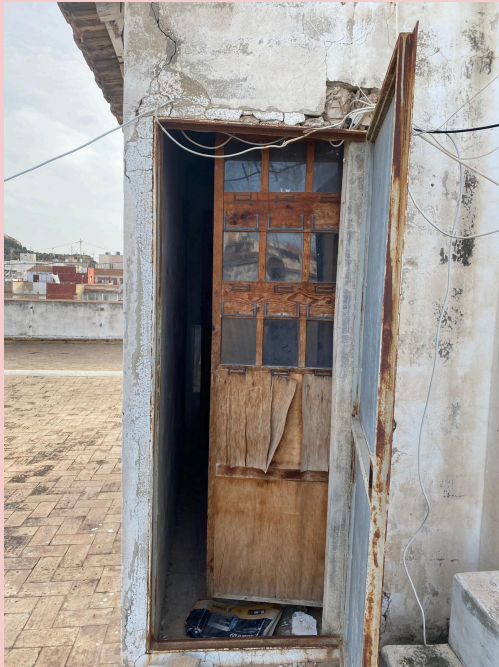
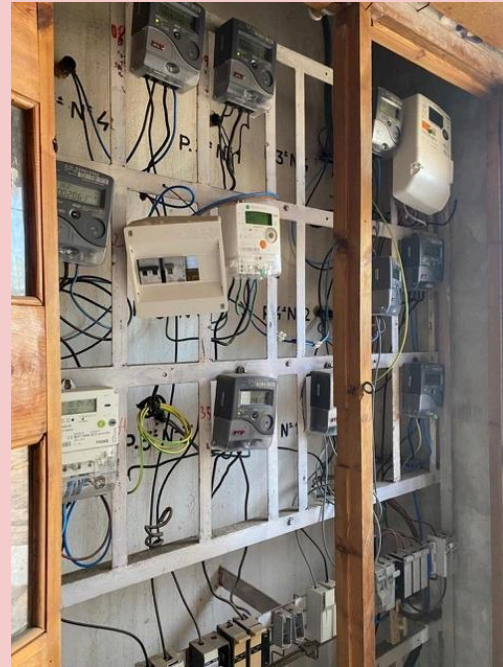
## Electrical distribution board. Overview and Defects

| Category | Condition | Description | Defects |
|---|---|---|---|
| Electricity | <br>bad | <ul style="list-style-type: none"><li>The main electrical distribution board serving the building is located on the roof. The electricity meters for all apartments are also installed in the same location</li></ul> | <ul style="list-style-type: none"><li><i>Unsatisfactory condition of the common electrical distribution board*</i></li><li><i>Potential non-compliance of the building's earthing system with current standards*</i></li></ul> |

- A significant number of surface-mounted conductors were observed, together with an inconsistent cable management arrangement and the partial absence of protective covers on certain electrical components. Based on a visual assessment, the overall condition of the electrical distribution board is below the standard generally expected of modern electrical installations in residential buildings;

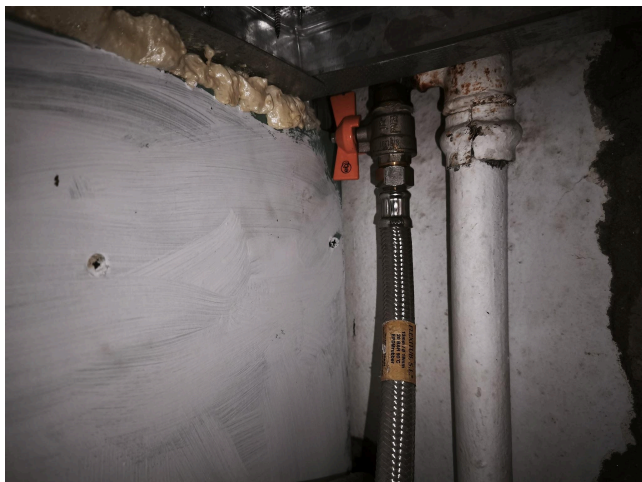
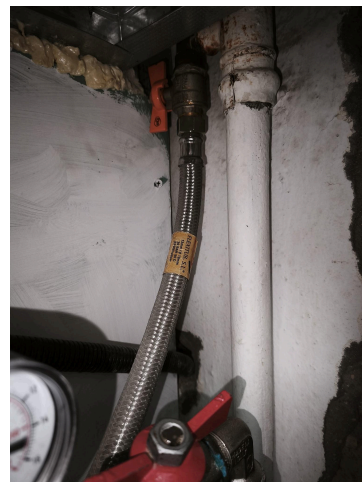
Cold water riser

- One visible cold water supply riser within the apartment is of metal construction. Signs of corrosion were observed; however, no evidence of leakage was identified at the time of the inspection;
- The drainage risers are concealed behind the bathroom finishes and were not accessible for inspection. According to the owner, the apartment is served by three drainage risers (two black-water risers and one grey-water riser). The risers are of metal construction, while the sections within the apartment have been replaced with PVC pipework.

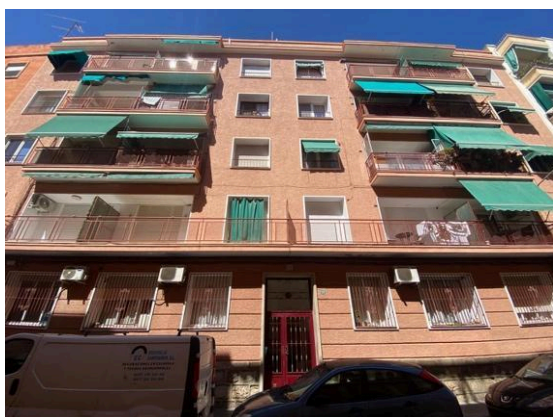
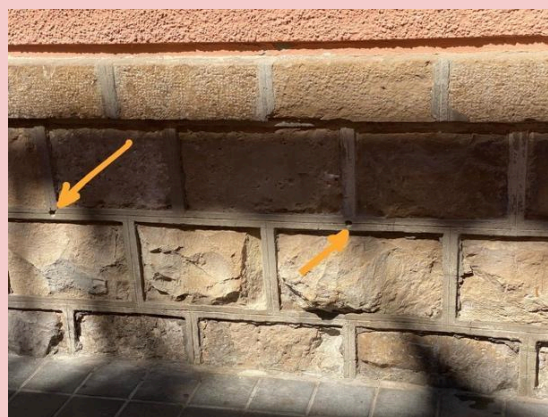
## Facades. Overview and Defects

- Ventilation openings in the lower section of the façade may indicate attempts to mitigate elevated moisture levels within the building fabric.

- Request information from the Owners' Association (Comunidad de Propietarios) or the property management regarding any works previously carried out, the technical justification for the installation of these ventilation openings, and any records of previously identified moisture or waterproofing issues affecting this part of the building.

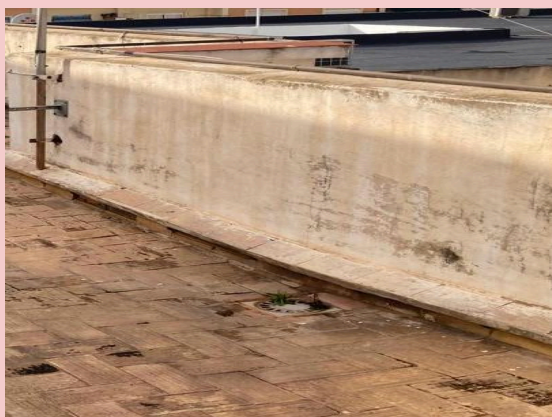
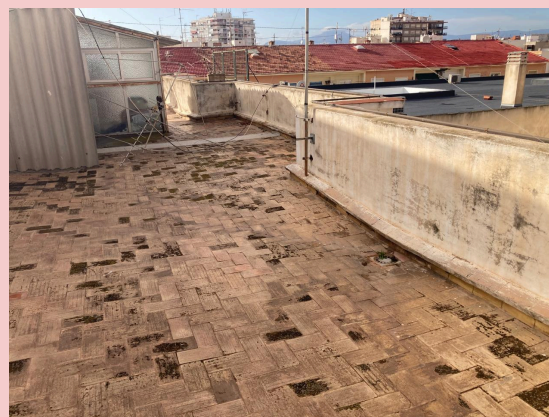
## Roof covering, rainwater drainage. Overview and Defects

| Category | Condition | Description | Defects |
|---|---|---|---|
| Roof covering | <br>average | <ul style="list-style-type: none"> <li>The roof is of flat construction, finished with ceramic floor tiles laid over a waterproofing membrane;</li> <li>No signs of structural failure of the roof, significant deformation of the roof covering, or obvious evidence of active water ingress were identified at the time of the inspection.</li> </ul> | <ul style="list-style-type: none"> <li><i>Extensive biological growth (moss and algae) was observed across the roof surface, which may indicate recurring moisture retention and inadequate maintenance;</i></li> <li><i>Foreign objects and construction debris were present on the roof surface.</i></li> </ul> |

- A lightweight rooftop plant room is present and is in a condition requiring maintenance and general cleaning;
- The roof drains and associated rainwater drainage components are partially obstructed and require preventive cleaning to ensure the free flow of rainwater;
- The roof parapets exhibit signs of normal weather-related deterioration of the paint finish together with localised surface contamination consistent with long-term exposure and service conditions.

- Request information from the Owners' Association (Comunidad de Propietarios) or the property management regarding the roof maintenance programme, and confirm that the necessary remedial works are scheduled to be carried out in the near future;

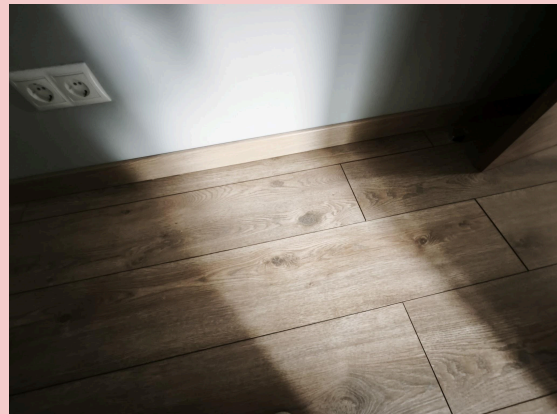
Bedroom #1

An area of laminate flooring of approximately 1 m<sup>2</sup> was identified exhibiting the following defects:

These findings may indicate localised irregularities in the subfloor or deficiencies in the installation of the laminate flooring.

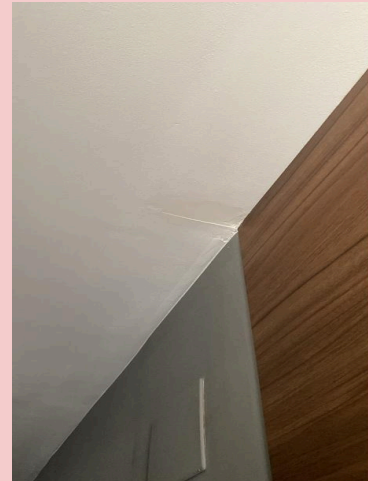
Crack in ceiling

- A localised cosmetic crack was identified in the ceiling at the junction between the entrance hall and the kitchen;
- The crack exhibits no signs of structural movement and is considered to be a non-structural finishing defect. The estimated cost of local cosmetic repair is approximately EUR 100–150.

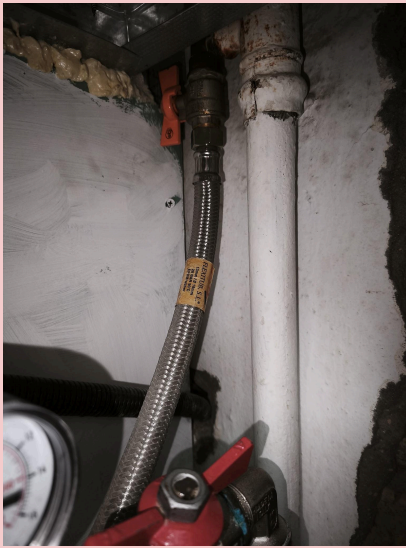
#### Connection of water riser to water distribution system

- The connection between the cold water supply riser and the apartment's water distribution system is made using a flexible hose. This solution is generally considered less reliable than a rigid pipe connection due to the higher risk of hose failure over time and the typically shorter service life of flexible connectors.

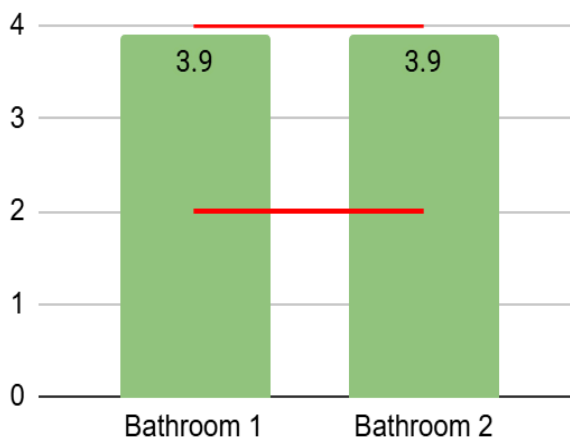
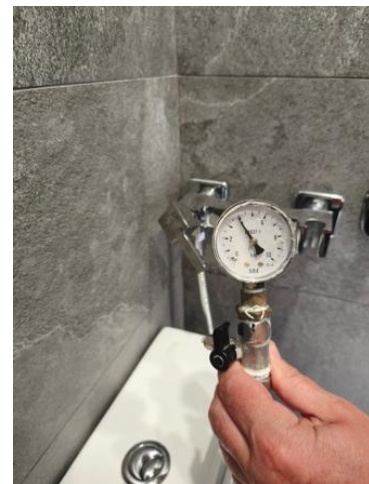
#### Water pressure testing (bar)

- A noticeable reduction in water pressure was observed in Bathroom No. 2 while the shower in Bathroom No. 1 was in use. This observation may indicate a local flow restriction within the affected water supply branch or the associated mixer valve. Possible causes include clogged inlet strainers, a faulty thermostatic cartridge, or a partially closed isolation valve.

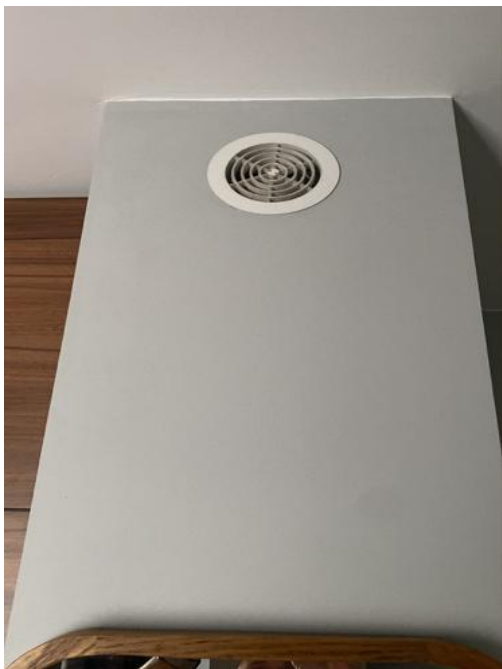
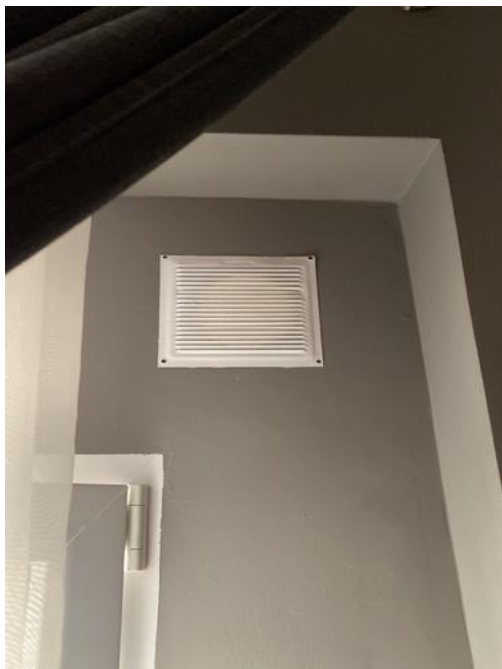
| Vents in the bedroom 1 | Vents in the bedroom 1 |

- A ventilation duct passing through the external wall of the building was identified in the master bedroom. The design and construction of the duct suggest that it may have originally served as a chimney flue for a stove or fireplace. It currently functions as a natural exhaust ventilation duct for the room.
- No backdraft damper is installed within the ventilation duct. Under certain weather conditions (wind pressure and temperature differences), this may result in reverse airflow and the ingress of outdoor air into the room.
