**HOUSE DOCTOR**

# Inspection Report

**03501, Alicante, Your Dream House Location, Alicante, Spain**

**26.06.2026**

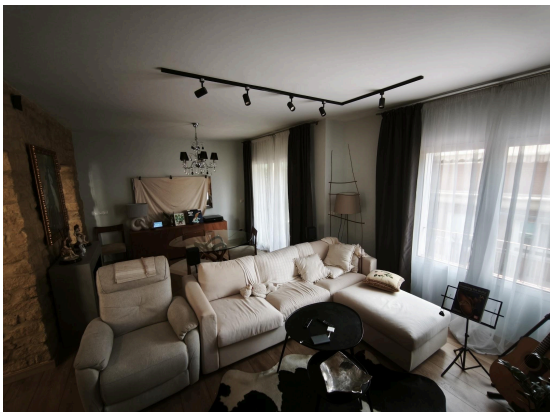
Living room

Some of the internal partition walls are of plasterboard construction, while others have a plaster finish. The kitchen wall features a decorative stone-effect finish. All wall surfaces are painted.

Minor local deviations from perfectly true and level surfaces were observed; however, these are typical of residential properties and are not considered to constitute significant defects.

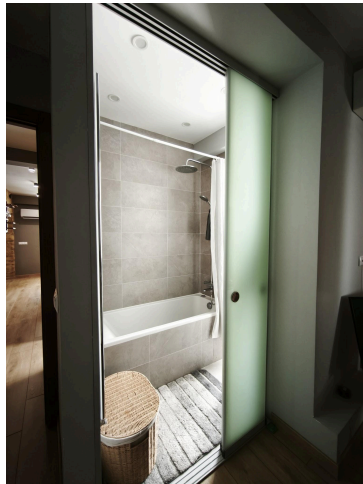
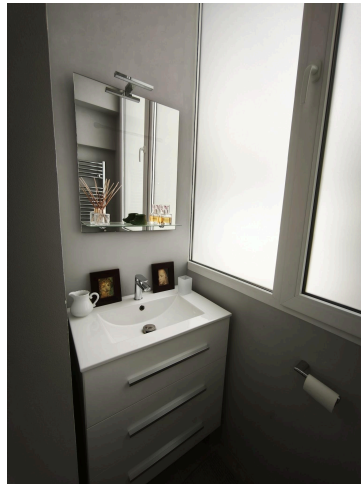
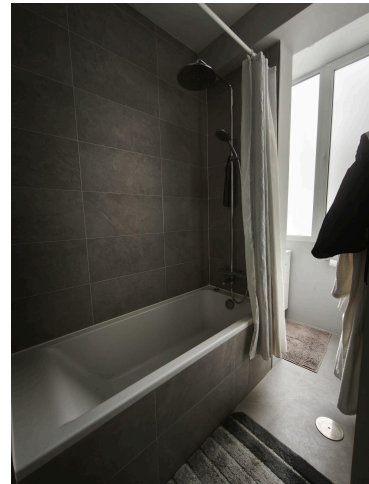
**Bathroom #1**

- The bathroom walls are clad with porcelain tiles. The wall finishes are in good condition. No damage or loss of integrity to the tiled surfaces was identified. The grout joints are in satisfactory condition, with no evidence of deterioration or failure;
- The shower area and the acrylic bath are in good condition. No visible damage or evidence of sealant failure was identified.

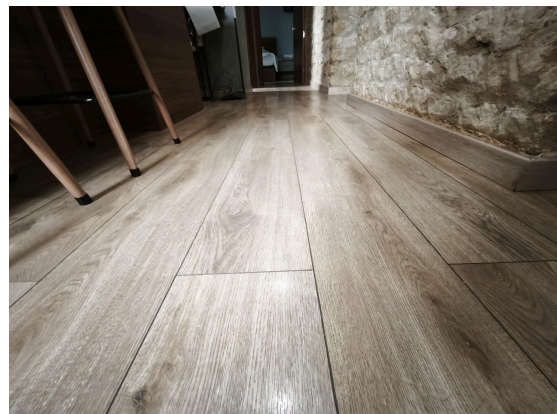
Kitchen

- Laminate flooring is installed throughout all living areas. The overall quality of the flooring is visually assessed as above average.

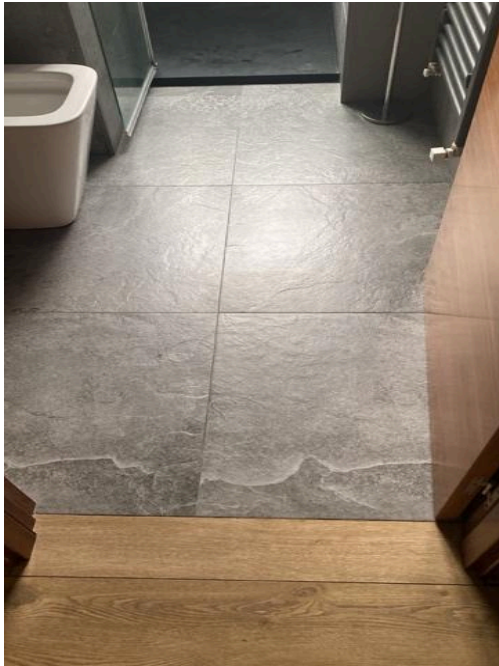
Bathroom #1

- The bathroom floors are finished with porcelain tiles. No cracks, chips, or signs of debonding from the substrate were identified.

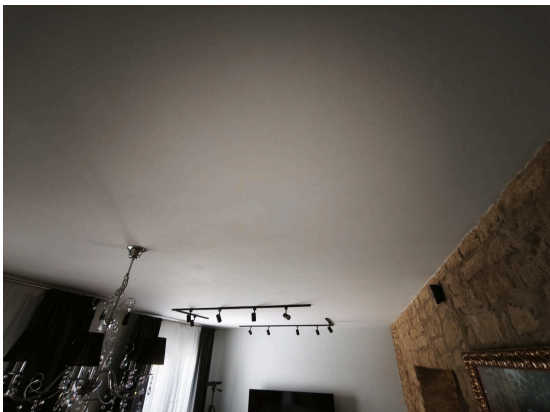
Living room

- The ceilings are of plasterboard construction. The ceiling height throughout the living areas is approximately 2.70 m.

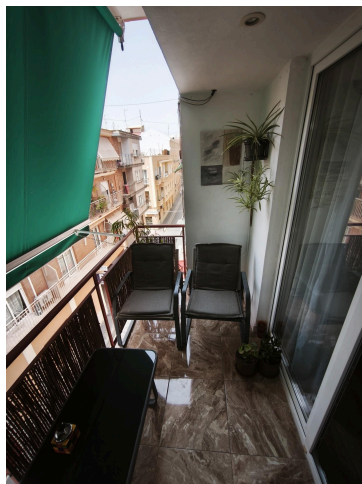
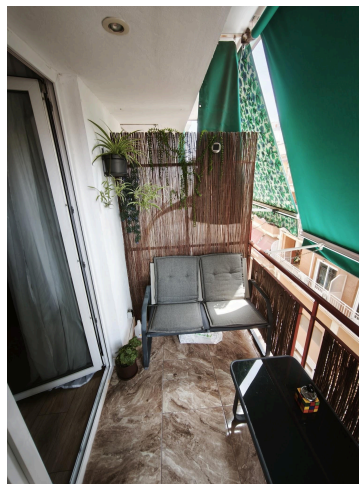
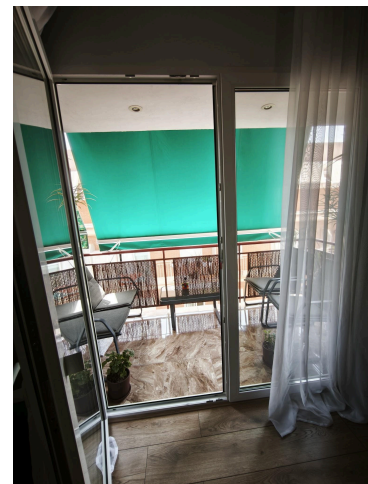
- The balcony is of open design. Its construction provides for the natural drainage of rainwater. The balustrade is in serviceable condition, with no signs of structural distress or instability identified;
- The balcony floor is finished with ceramic tiles. No cracks, debonding, or deterioration of the floor finish were identified.

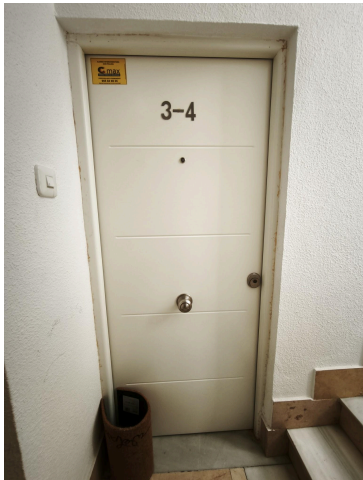
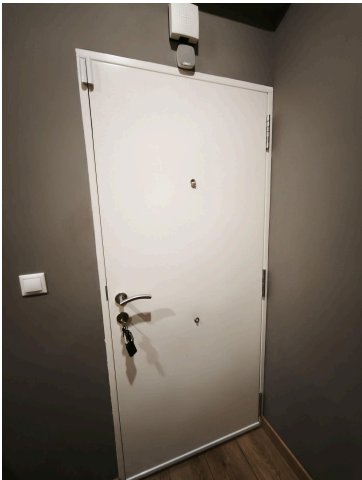
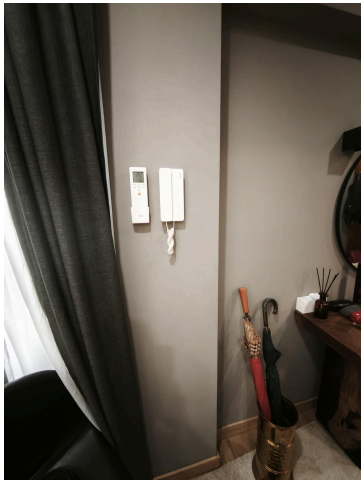
| Entrance door | Entrance door | Intercom |

- A reinforced steel entrance door is installed. The door is of reduced height compared with modern standard dimensions. This should be taken into consideration, as it may limit replacement options in the future;
- The entrance door is fitted with a single lock;
- The door operates correctly, with no signs of misalignment or distortion. The locking mechanism functions properly.

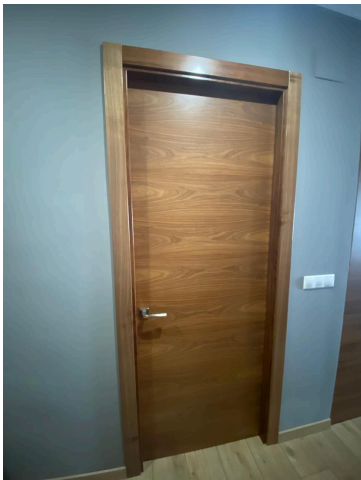
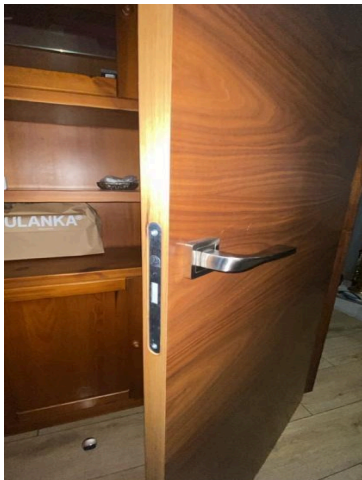
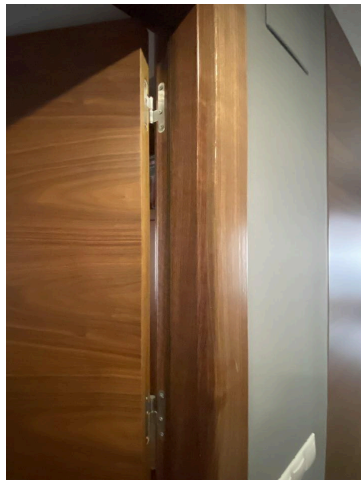
| Room doors | Room doors | |

- The internal doors are properly aligned, with no signs of distortion or misalignment, and open and close correctly.

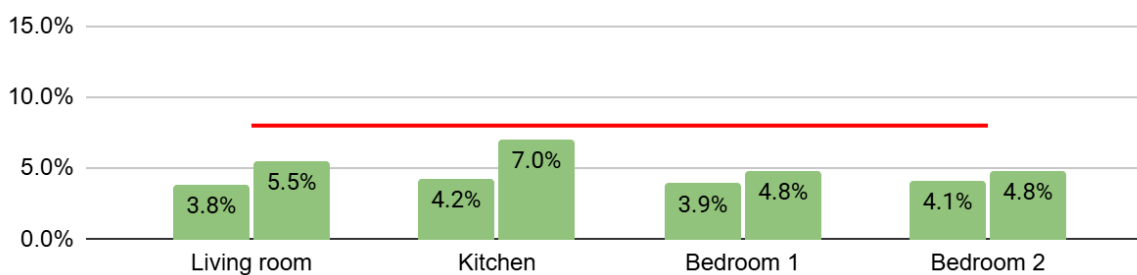
Living rooms and kitchen, [ wall | floor ]

| Category | Condition | Description | Defects |
|---|---|---|---|
| Floor&wall humidity in living areas and kitchen | <br>good | <ul style="list-style-type: none"> <li>The measured moisture content of the walls in the living areas was 3–5% (acceptable maximum: 8%)</li> <li>The measured moisture content of the floors was 3–5% (acceptable maximum: 8%)</li> </ul> | |

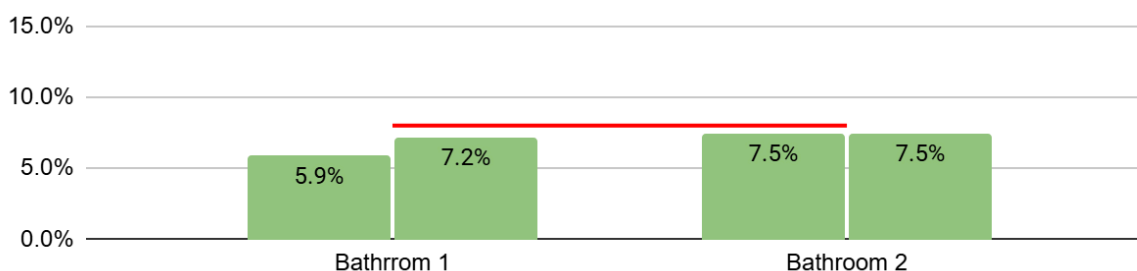
Bathrooms [ wall | floor ]

| Category | Condition | Description | Defects |
|---|---|---|---|
| Floor& wall humidity in wet areas | <br>good | <ul style="list-style-type: none"> <li>The measured moisture content of the bathroom walls and floors ranged from 4% to 7%, indicating no evidence of excessive moisture or dampness</li> </ul> | |

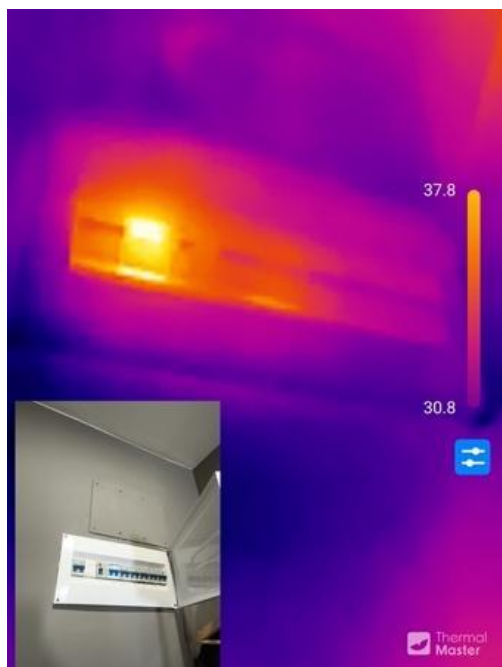
Thermal imaging inspection of the electrical distribution board revealed no evidence of:

- localised overheating of the circuit breakers;
- overheating of the residual current device (RCD);
- overheating of electrical connections or terminal points.

The observed temperature distribution across the electrical distribution board was generally uniform, with no abnormal thermal anomalies identified.

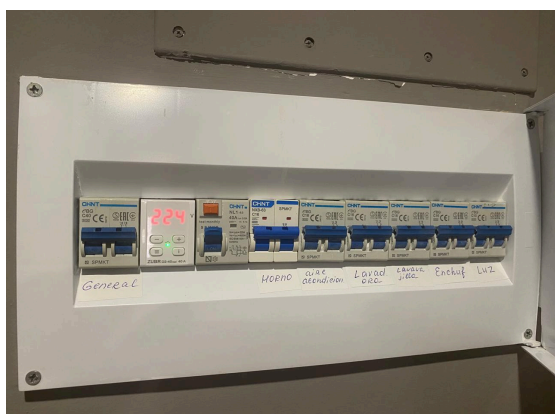
Electrical lines:

- Electric oven - 16A
- AC - 16A
- Washing machine - 16A
- Dishwasher - 16A
- Power outlets - 16A
- Lighting - 10A

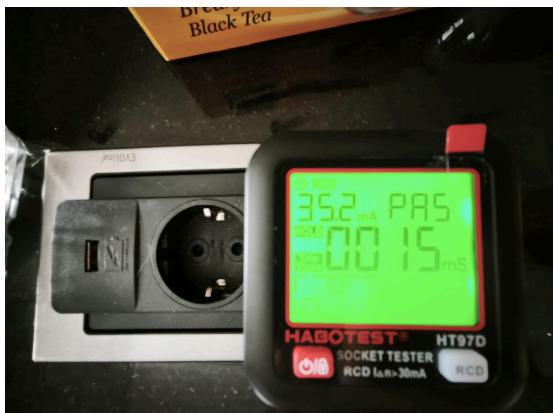
### RCD/GFCI testing

- The 30 mA RCD operated correctly during testing. The measured tripping time was 15 ms, indicating satisfactory performance of the protective device.

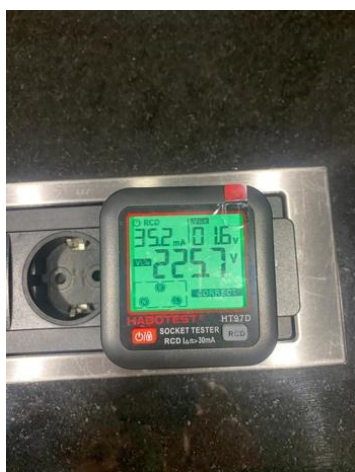
### Electrical outlet testing

- All power outlets are operational and have PE connection, no loose or damaged outlets found
- All lighting switches are operational, no loose or damaged switches found

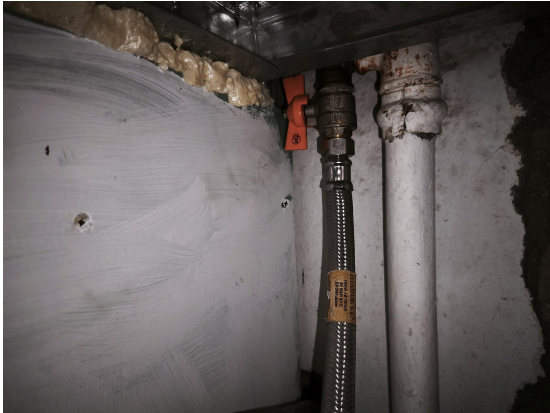
Water riser and main shutoff valve

- The main cold water shut-off valve is installed on the branch connection from the building supply riser and was found to be in operational condition;
- The water meter is installed downstream of the main shut-off valve. It is readily accessible, and the meter readings can be easily read;
- A flushable mechanical water filter is installed downstream of the water meter;
- The apartment is served by a manifold water distribution system for both cold and hot water. Individual supply pipes run from the manifolds to each plumbing fixture;
- The apartment contains two separate cold and hot water distribution zones, with two manifold assemblies. One manifold assembly is located in Bathroom No. 2, while the second is installed inside the kitchen cabinet housing the gas-fired boiler.

- The connection between the cold water supply riser and the apartment's water distribution system is made using a flexible hose. This solution is generally considered less reliable than a rigid pipe connection due to the higher risk of hose failure over time and the typically shorter service life of flexible connectors.

- Replace the flexible connector from the cold water supply riser with rigid pipework

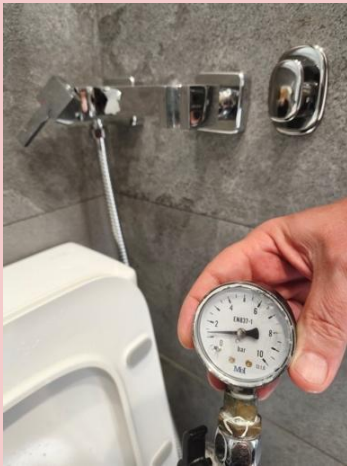
**Water pressure drop**

- A noticeable reduction in water pressure was observed in Bathroom No. 2 while the shower in Bathroom No. 1 was in use. This observation may indicate a local flow restriction within the affected water supply branch or the associated mixer valve. Possible causes include clogged inlet strainers, a faulty thermostatic cartridge, or a partially closed isolation valve.

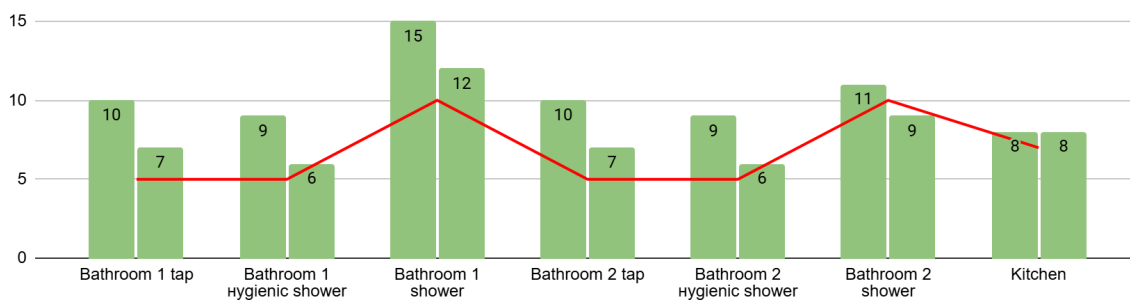
**Water flow rate [ cold | hot ], l/min**

- Water flow rate is in line with generally recommended minimal comfortable rates (bathroom tap - 5l/min, kitchen - 7 l/min, shower - 10l/min);
- Flow rates were measured with one tap or shower open at a time. As defect above indicates, flow rates may fall significantly if more than one plumbing fixture is used simultaneously

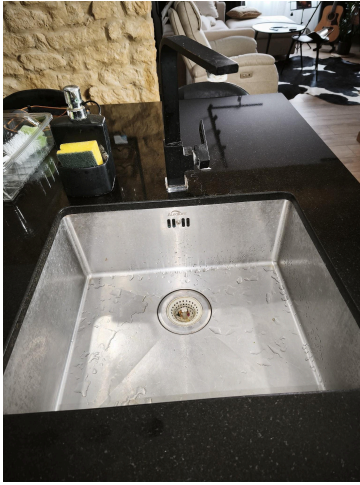
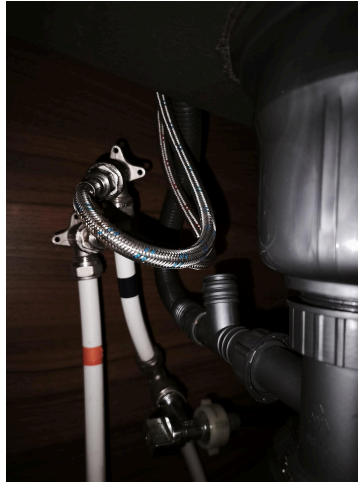
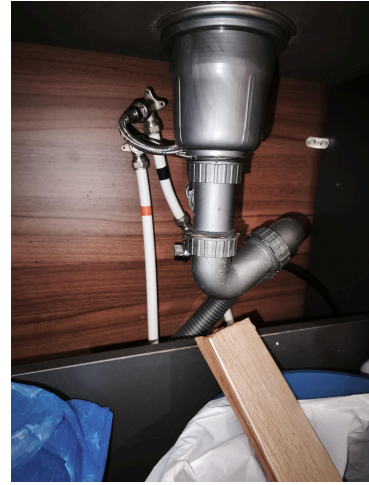
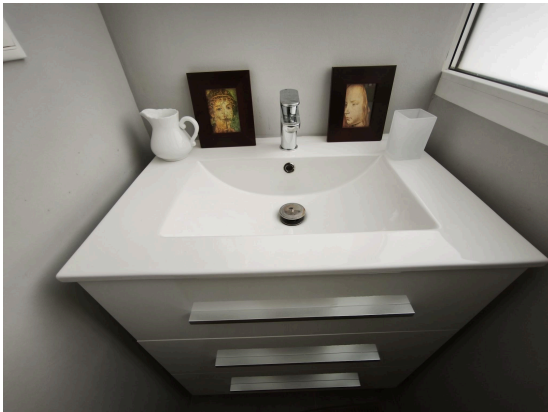
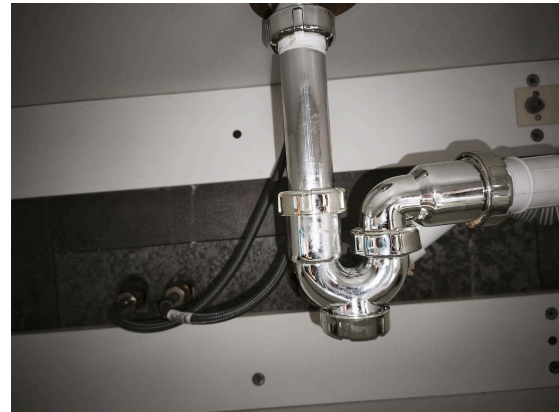
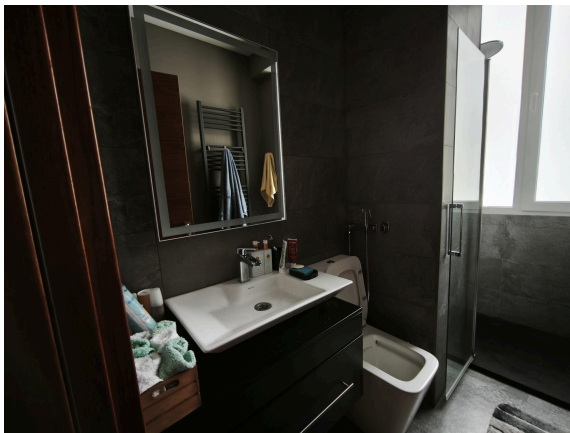
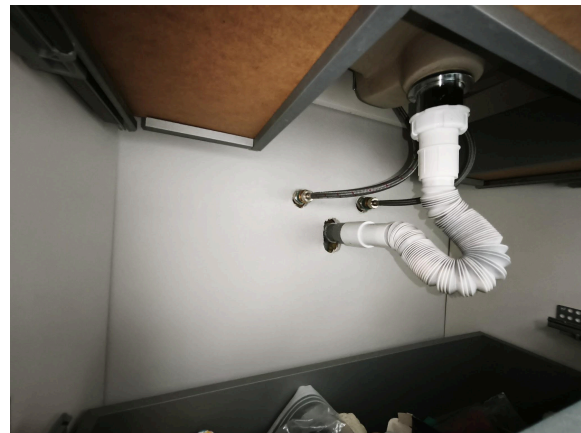
- All plumbing fixtures are connected using flexible braided supply hoses. No individual isolation valves are installed at the wall outlets. Water isolation is provided by the shut-off valves located on the distribution manifolds;
- The condition of the connections and flexible supply hoses was found to be good. No signs of leakage, corrosion, or deterioration were observed.

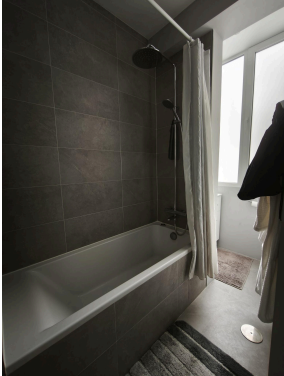
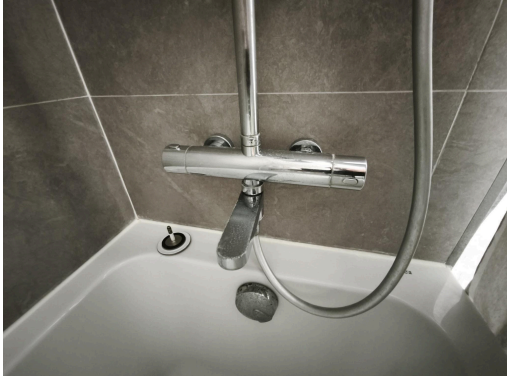
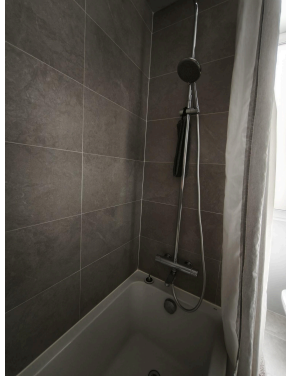
| Bathroom 1 bathtub | Bathroom 1 mixer tap | Bathroom 1 shower |

- Bathroom No. 1 is equipped with a bathtub fitted with a shower. The mixer tap and its visible connections showed no signs of leakage, corrosion, or other visible defects;

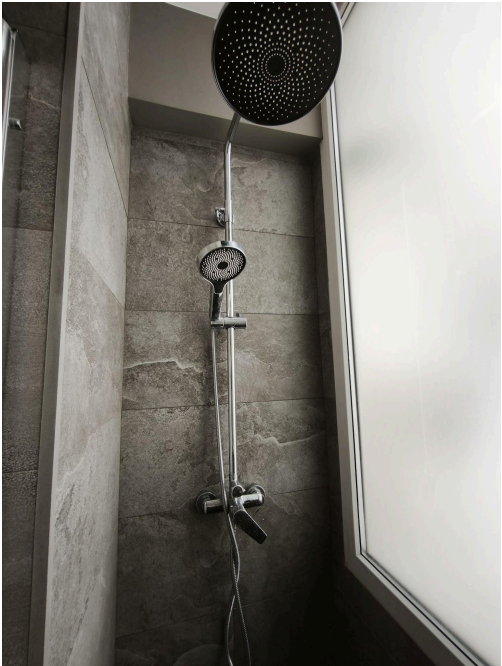
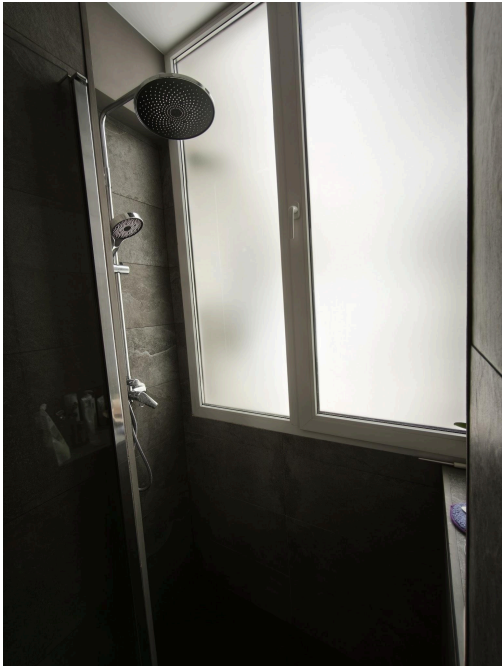
| Bathroom 2 shower | Bathroom 2 shower |

- Bathroom No. 2 is equipped with a shower. No visible signs of leakage, corrosion, or mechanical damage were observed at the shower mixer or its visible connections;

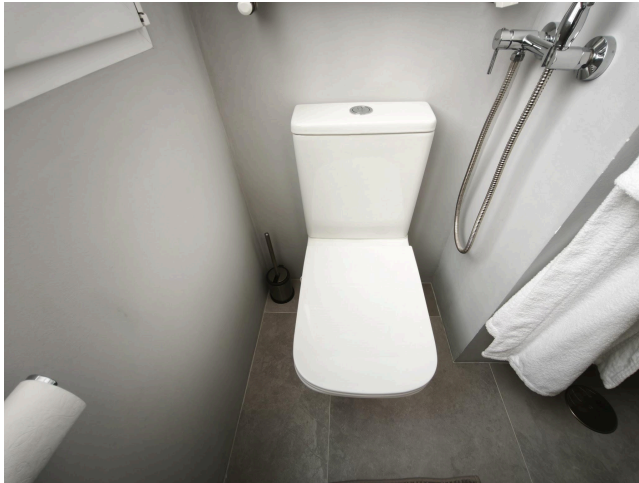
Bathroom 1 toilet

- Both bathrooms have one-piece toilets. Water supply hoses are hidden behind the toilet / water tank and could not be inspected. There are hygienical showers next to each toilet with cold and hot water connected;
- Toilet water fill valves and flush valves are operational, no signs of leaks identified;

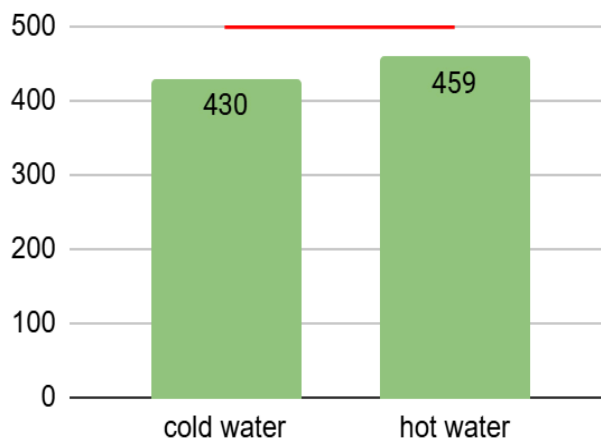
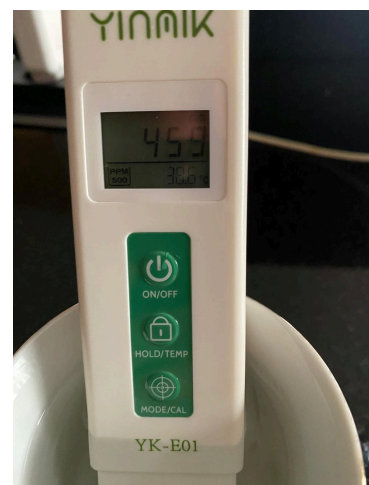
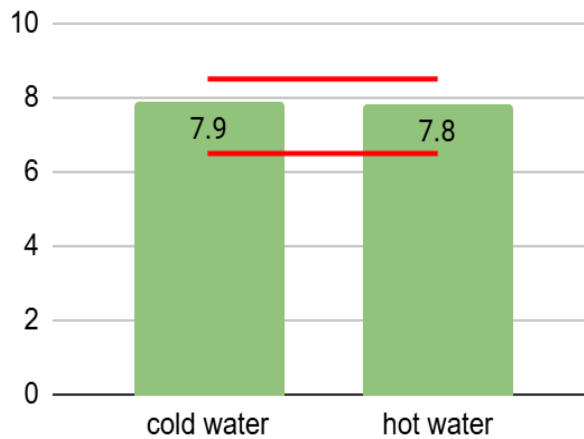
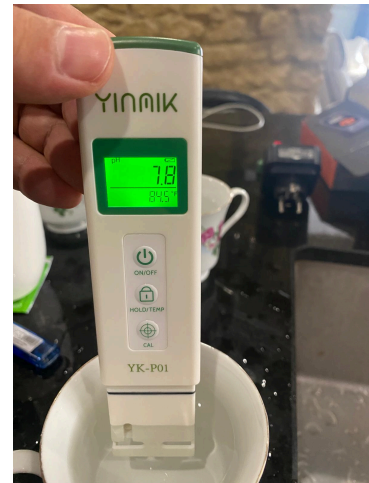
TDS measurement (ppm500)

- The measured total dissolved solids (TDS) level was slightly above 400 ppm (PPM500 scale), indicating a relatively high mineral content typical of the local water supply. Such water may have a noticeable mineral taste;
- For occupants who prefer water with lower mineral content, installation of a reverse osmosis filtration system may be considered for drinking and cooking purposes;
- The measured pH value was within the normal range for potable water.

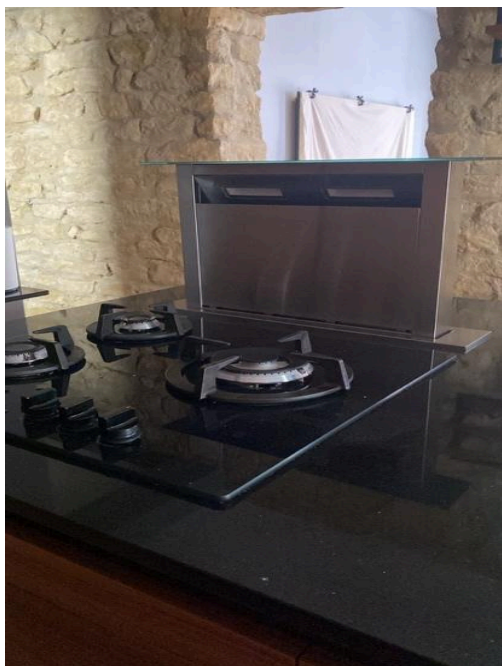
Kitchen air filtering system

- A permanent ventilation opening is provided in the external kitchen wall, discharging into Patio No. 2. This opening has been installed in accordance with the gas safety requirements applicable to rooms containing gas-fired appliances and provides a continuous supply of outdoor air;
- A kitchen extractor unit is integrated into the kitchen island;
- The extractor operates in recirculation mode. It is not connected to a ventilation duct, and no air is discharged outside the apartment. Air treatment is achieved by means of activated carbon filters;

The installed system provides partial removal of odours and grease particles through air filtration; however, it does not replace a dedicated extract ventilation system that discharges air to the exterior.

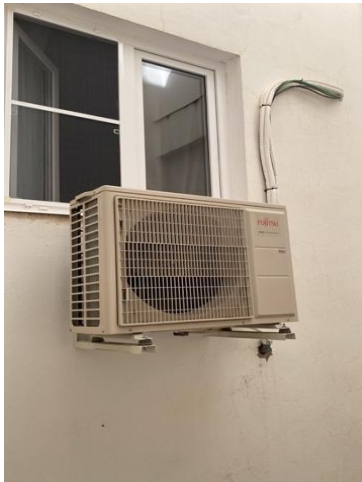
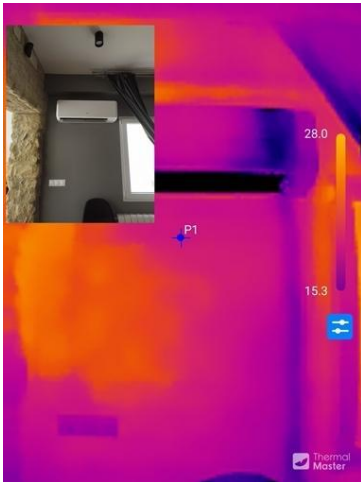
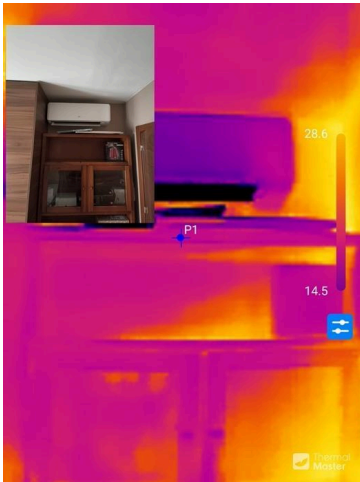
| AC#1, outdoor unit | AC#1, Indoor unit #1 | AC#1, Indoor unit #2 |

A Fujitsu outdoor air-conditioning unit is installed in Patio No. 2. Two indoor units are connected to this outdoor unit:

At the time of the inspection, the system was operating under normal conditions. No signs of insufficient cooling performance, equipment malfunction, abnormal noise, excessive vibration, refrigerant leakage, or other operational irregularities were observed during the inspection.

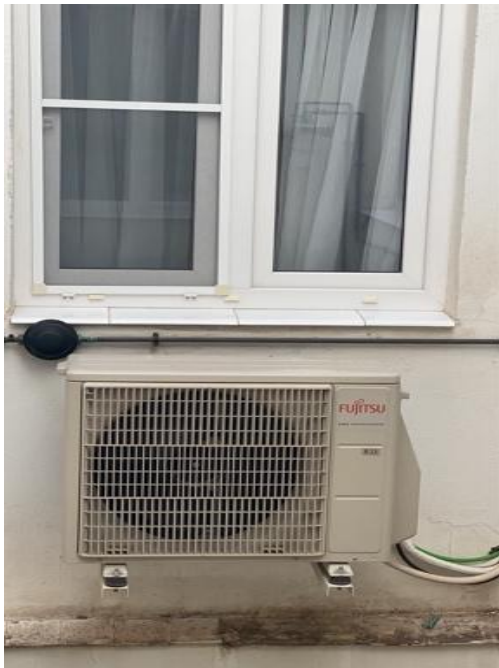
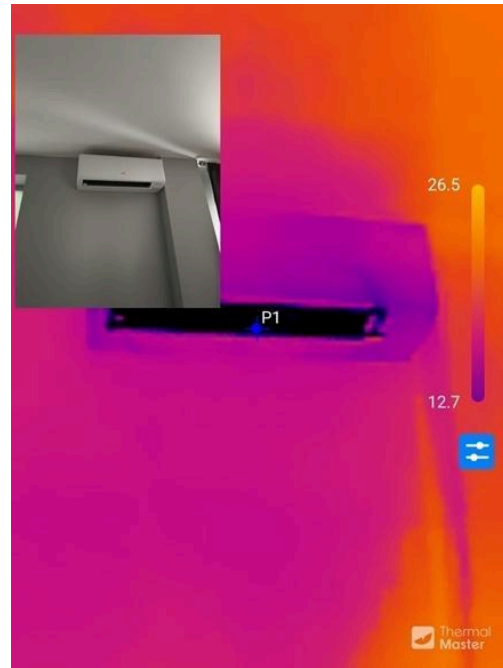
AC#2, outdoor unit

- A separate Fujitsu outdoor air-conditioning unit is installed in Patio No. 1. This outdoor unit serves the master bedroom exclusively. Condensate from the indoor unit is discharged into the drainage system of Bathroom No. 1.
- The installation is configured as a single-split system comprising one outdoor unit and one indoor unit. The total cooling capacity of the system is approximately 9,000 BTU/h.
- At the time of the inspection, the system was operating under normal conditions. No signs of insufficient cooling performance, equipment malfunction, abnormal noise, excessive vibration, refrigerant leakage, or other operational irregularities were observed during the inspection.

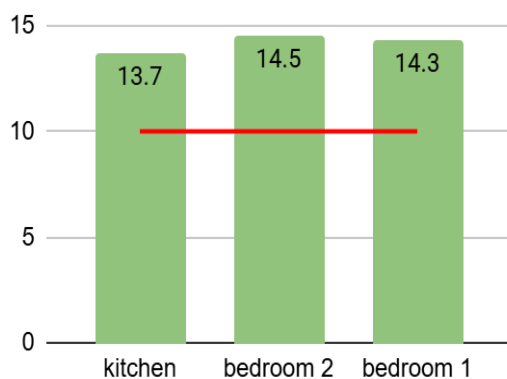
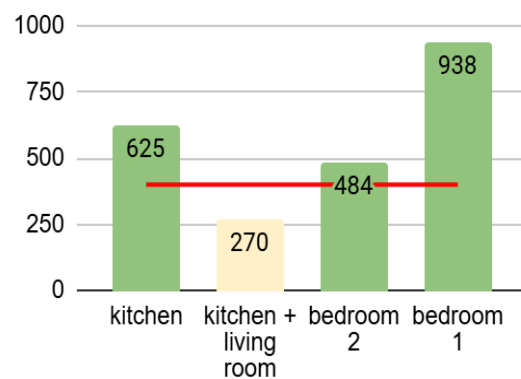
AC temperature split, C0

- Air temperature measurements taken at the outlets of the indoor units indicate that all air-conditioning units are operating normally and provide sufficient cooling of the supplied air.
- The cooling capacity assessment indicates that the installed capacity is sufficient for the rooms in which the indoor units are installed.
- In the case where one indoor unit is required to serve both the kitchen and the living room, the available cooling capacity may be insufficient (recommended minimum: 400 BTU/m<sup>2</sup>; calculated value: 270 BTU/m<sup>2</sup>). Installation of an additional air-conditioning unit in the living room may be required.

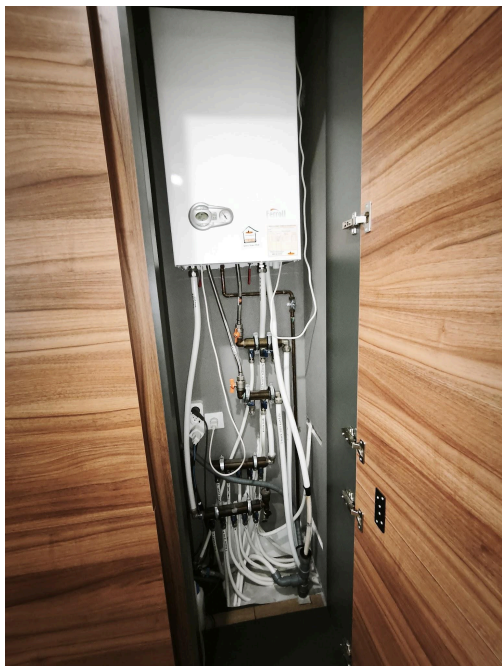
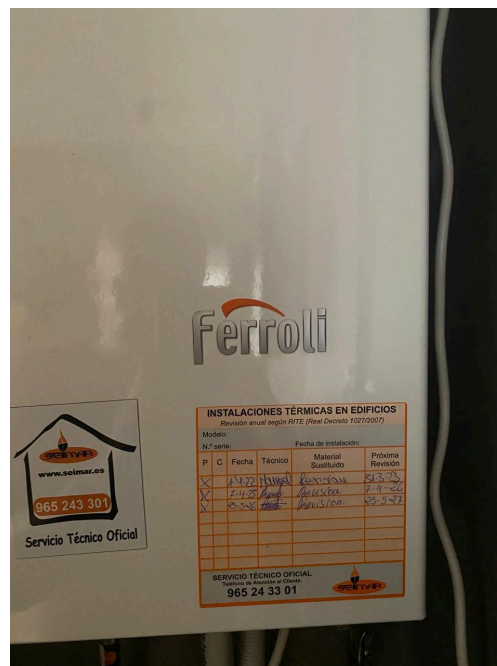
Gas boiler

- The boiler is concealed within a kitchen cabinet. Combustion gases are discharged through a coaxial flue terminating in Patio No. 1;
- The most recent maintenance was carried out by a qualified service company in May 2026;
- At the time of the inspection, the boiler was found to be in operational condition. Visual inspection revealed no signs of water leakage, no visible evidence of leakage from gas connections, no signs of corrosion, overheating, or other visible defects. The equipment was operating under normal conditions.

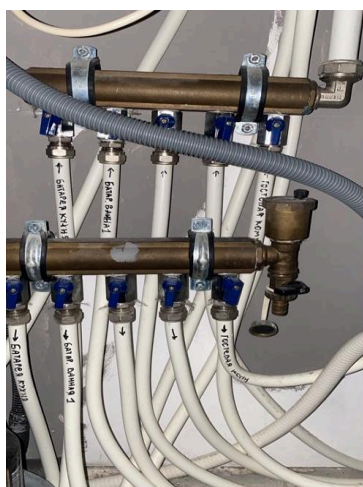
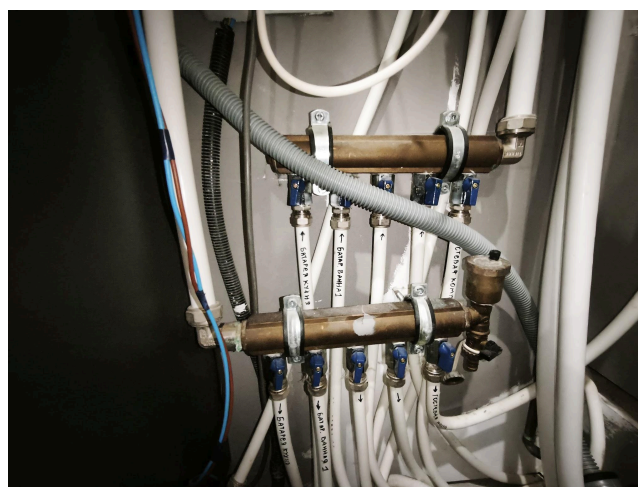
Heating system manifold

- The heating distribution system is arranged through manifold collectors and multilayer (PEX-AL-PEX) pipes concealed within the floor screed and wall structures;
- Each heating circuit is equipped with an individual isolation valve. This configuration allows maintenance or replacement of individual heating appliances without shutting down the entire apartment heating system;
- The heat distribution system appears to be of good installation quality and was found to be in operational condition. No signs of leakage were observed during the inspection.

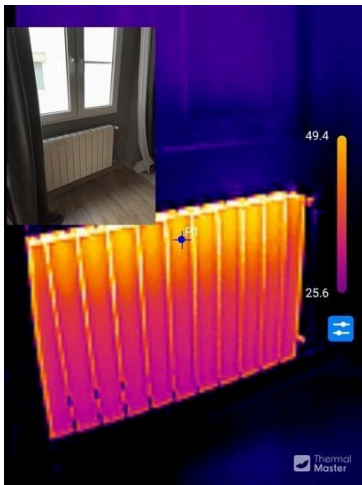
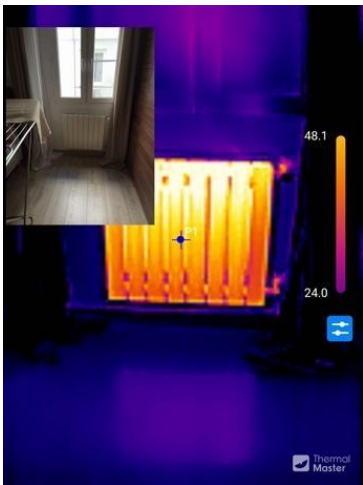
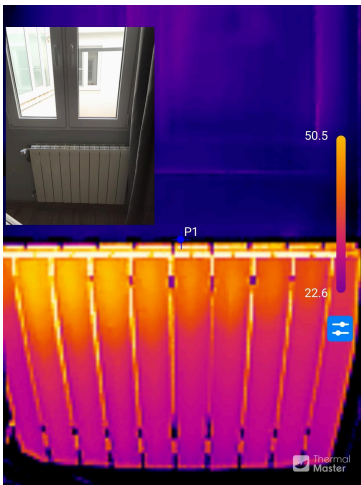
| Kitchen & living room radiator | Bedroom 1 radiator | Bedroom 2 radiator |

- The three radiators are installed beneath the windows, and each is fitted with an individual thermostatic radiator valve for regulating the flow of the heating medium;
- The radiators exhibit uniform temperature distribution over their entire surface. No areas of insufficient heating, which could indicate air locks, internal blockages, or non-functioning sections, were identified during the inspection;
- The measured radiator surface temperature ranged from 49 to 51 °C, which is consistent with normal heating system operation at the time of the inspection.

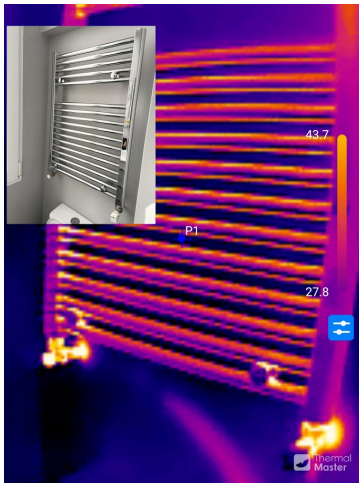
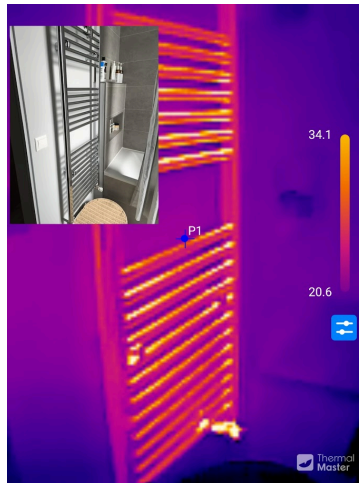
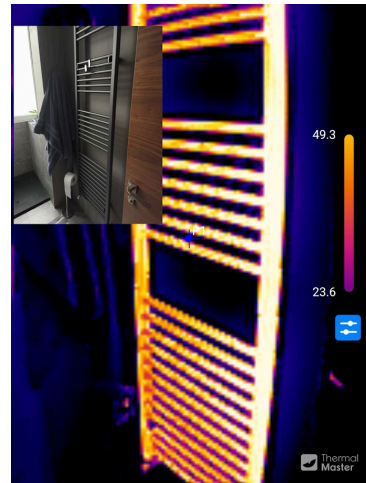
Bathroom 1 towel warmer

- Three water towel radiators are installed in the bathrooms. All were operating normally at the time of the inspection. No signs of corrosion, leakage, or other visible defects were observed.

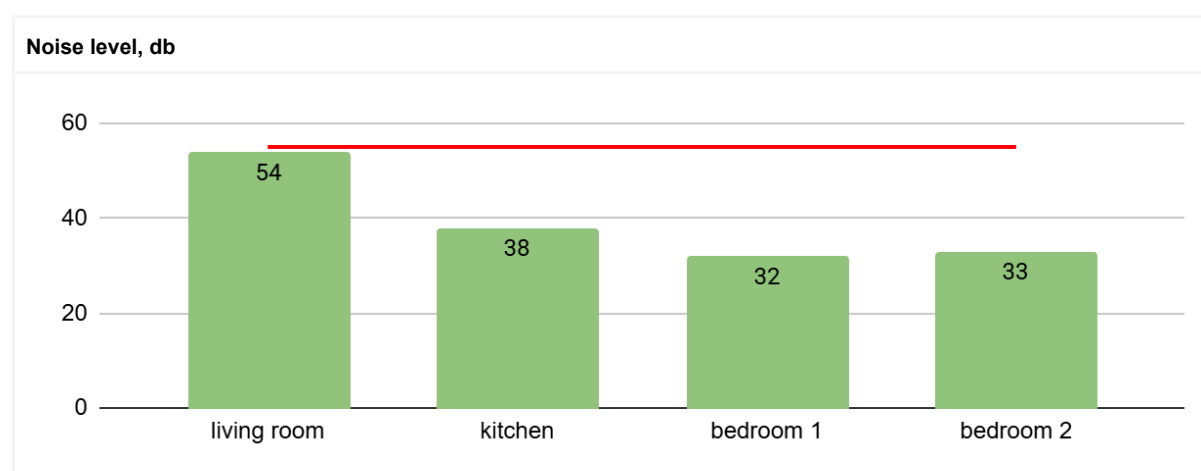
- The living room windows face a street with vehicle traffic, which explains the higher noise level. Even with the windows open, the noise level remains within comfortable values;
- The windows of the other rooms face the building's internal patios. The noise level in these rooms is low.

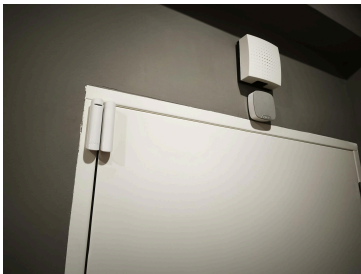
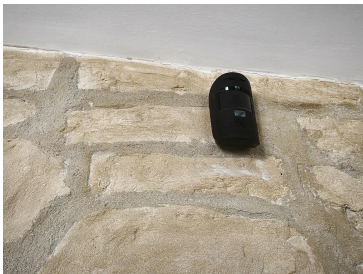
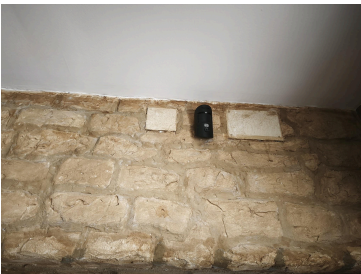
| Door sensor | Motion sensor and camera 1 | Motion sensor and camera 2 |

- The integrated security system comprises two motion detectors with built-in photo cameras, a door contact sensor, and a central control unit. The system supports two independent communication channels for alarm notifications and remote control: via the Internet and via the cellular network. The system can be operated remotely using a mobile application or a remote control key fob;
- At the time of the inspection, the ability to arm and disarm the security system using the remote control key fob was confirmed. Verification of the remaining system functions requires access to the mobile application registered to the property owner.
